Summary Feasibility Report and Conceptual Planning for Whitewater and Habitat Improvements Project Kern River Kernville, California

Prepared For
The Kern Valley River Council (KVRC)

Prepared By
Recreation Engineering and Planning
Shane Sigle, P.E.
485 Arapahoe Avenue
Boulder, CO 80302

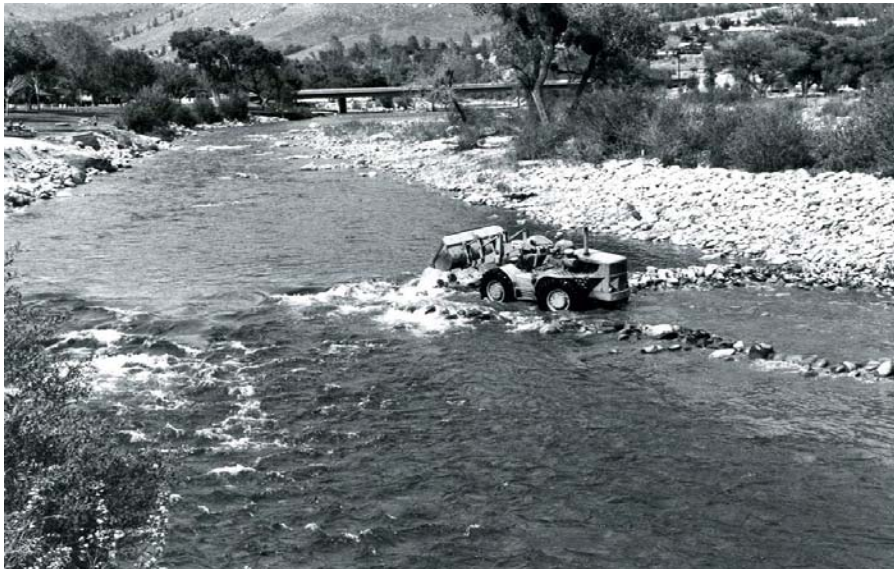
Figure 2: Construction photo of the original bank barbs

In-stream river improvements were originally done in the early 1980's to create grade stabilization and enhanced recreational opportunities (See Figure 2). Portions of those improvements are still visible in the channel, but now have minimal grade stabilization and recreational value. In addition, it appears the west bank has been stabilized with a combination of concrete floodwalls, dumped boulder riprap, and trees currently providing partial protection for a steep and eroding bank.

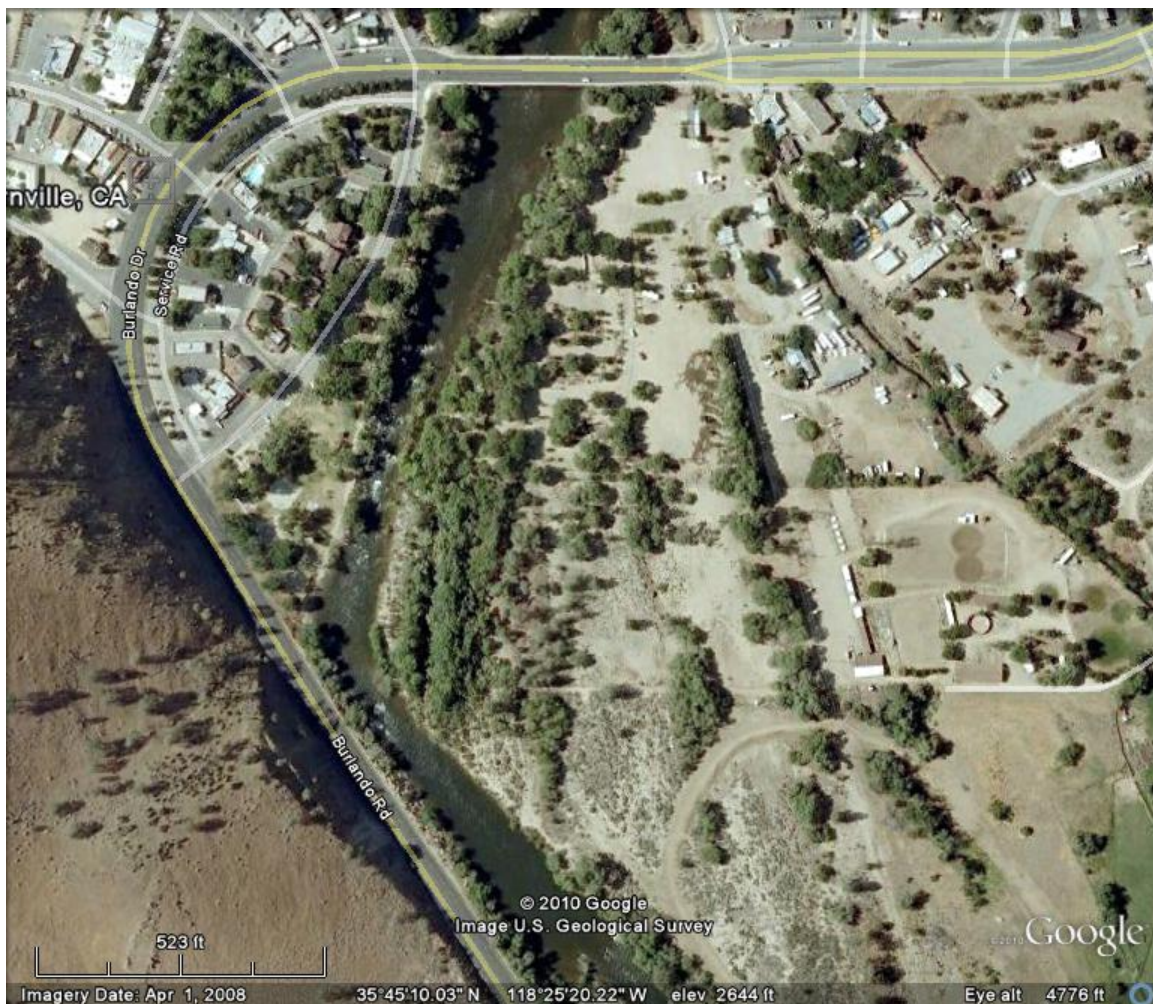
Figure 6. Aerial image of the Kern River near Kernville, CA showing the project area.

The project area spans from just downstream of the Burlando Road Bridge to an existing pool approximately 0.34 miles downstream. An aerial image of the project site is shown below in Figure 6. Modifications associated with this project include in-stream modifications, bank restoration and terracing, improved access points, and trails.

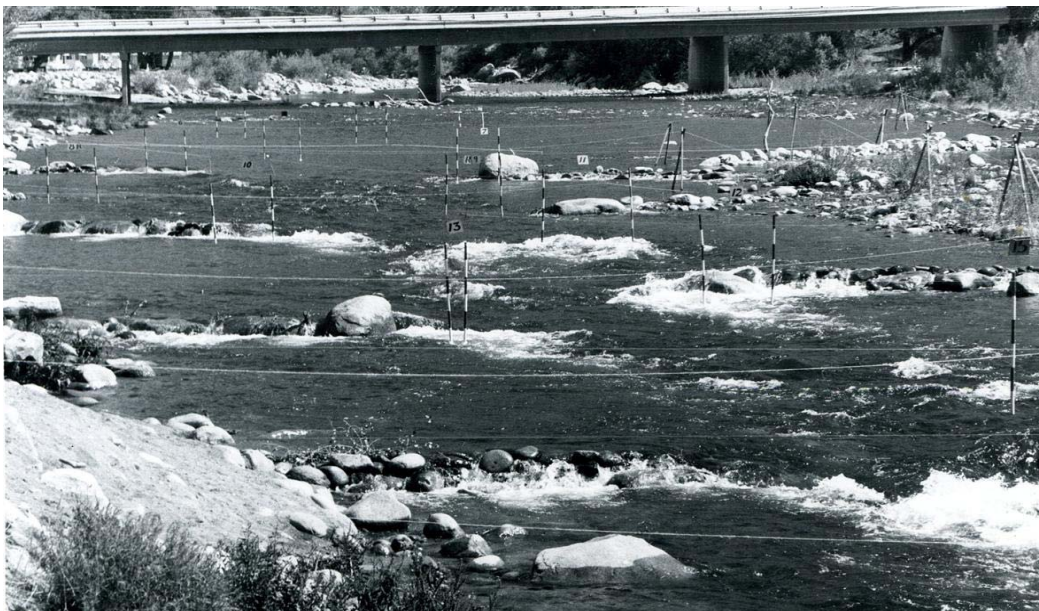
Figure 7: Original Instream improvements for recreation and habitat improvement

Previous river improvements include portions of multiple bank barbs that extend into the low flow portion of the river to stabilize grade and create whitewater features, random boulders placed near the thalweg to create whitewater features, and bank improvements for access (See Figure 7). Those improvements were completed in the 1980’s and REP understands no additional maintenance or improvements have occurred since that time. Because of that, only portions of the original improvements are still functioning as originally designed. Significant portions of the barbs have moved or washed downstream.

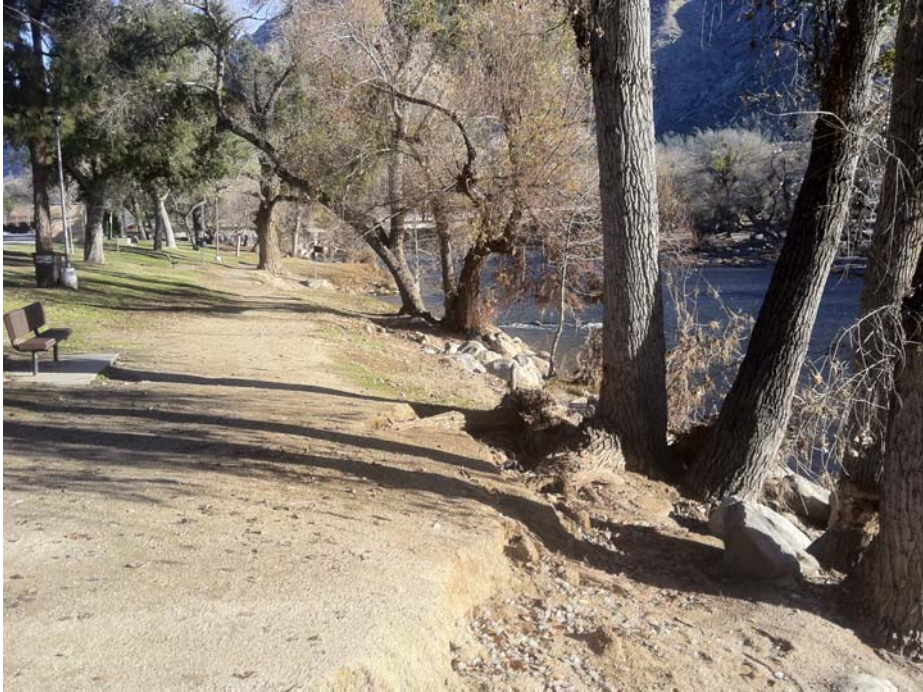
Figure 9: Erosion exacerbated by insufficient stabilization

The access points on the west bank associated with Riverfront Park have aggravated bank erosion primarily because of over-use (See Figure 8) and insufficient stabilization (see Figure 9 and Figure 10). No hardened access points exist within the park.

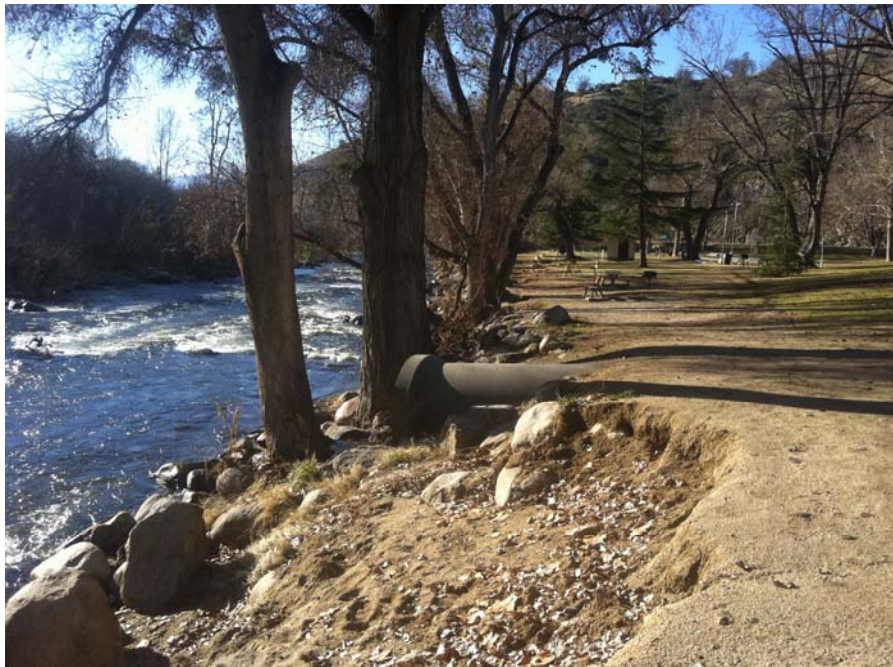
Figure 10: Erosion at Riverfront Park

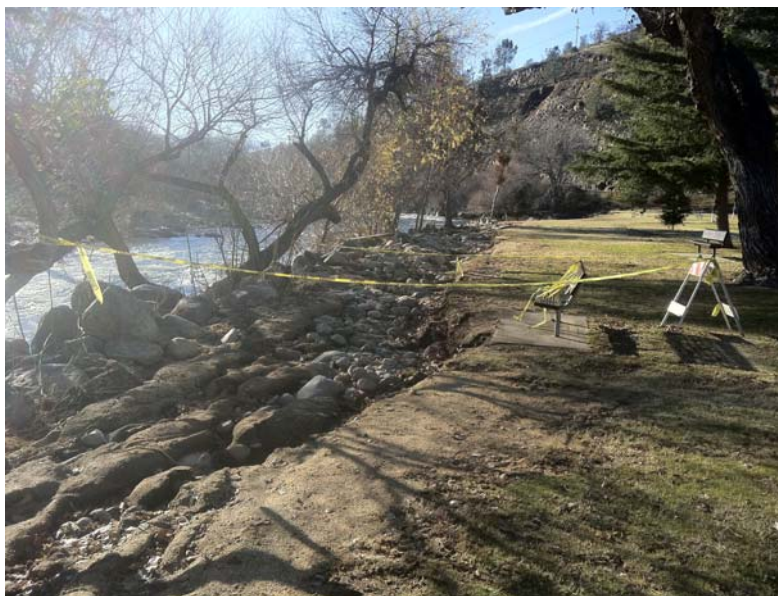
Figure 12: Degradation associated with flooding

The Kern River peaked at a flow of approximately 22,000 cubic feet per second (cfs) during December 2010. There have been four floods since 1966 with equivalent or greater magnitude (Figure 11 and Figure 12).

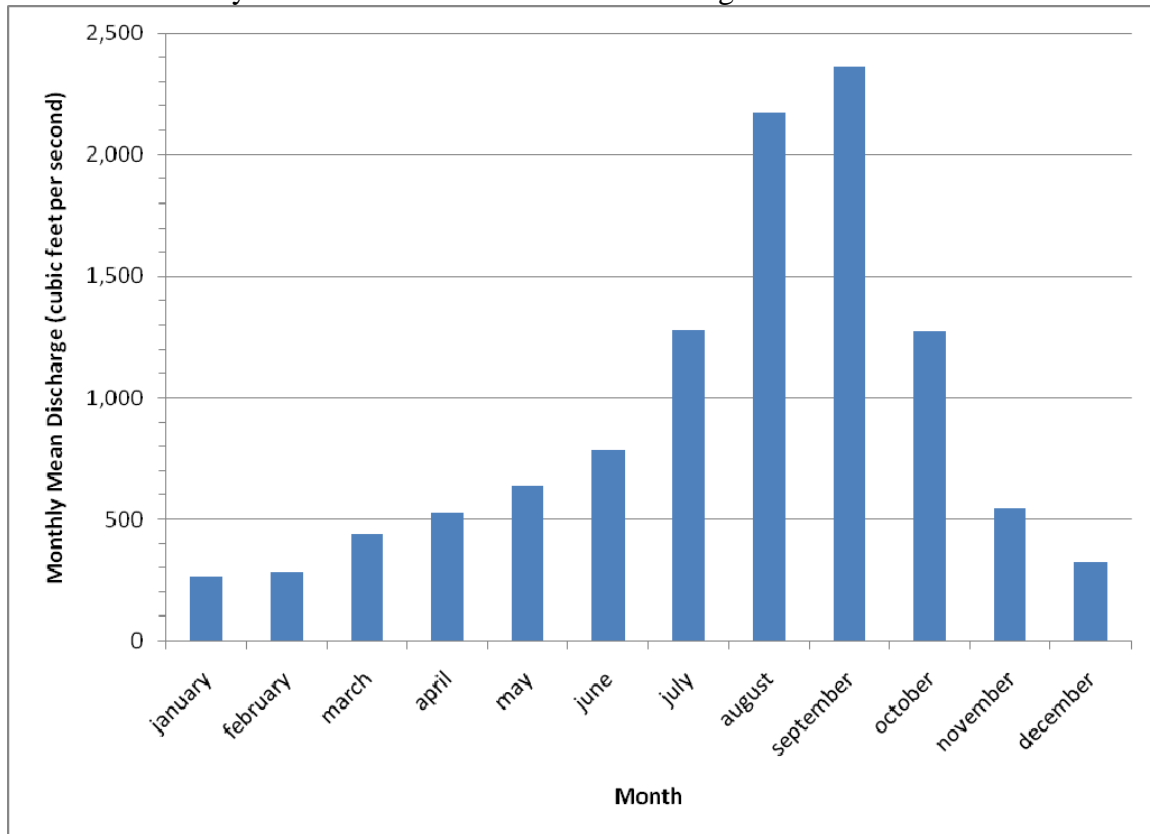
Figure 13: Mean monthly stream flow at USGS Gauge 11187000 located within the project area (Source <http://pubs.usgs.gov/wri/wri934076/stations/11187000.html> period of record 1874-1988 (discontinuous record))

The mean monthly streamflow at the site is shown in Figure 13.

High flows on the Kern River near Kernville, CA generally occur in the months of June through October, and drop in the winter. Mean monthly flows range from less than 300 cubic feet per second (cfs) in January to approximately 2,300 cfs in September (Figure 13). The peak flow on record (according to conversations with Mr. Derrick Tito, Hydrographer for Southern California Edison) reached over 100,000 cfs in 1966. Although the weather in the area may not be hospitable during all months, the flow conditions support whitewater recreation all year long.

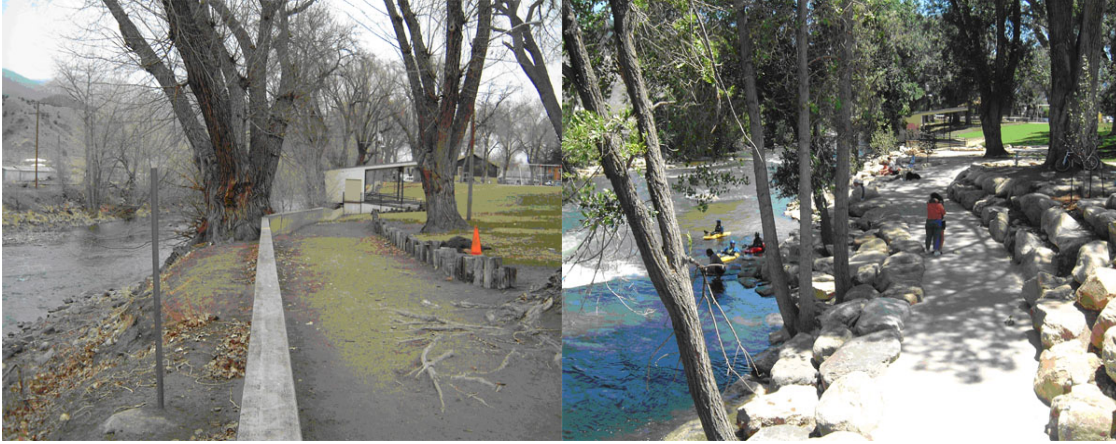
Figure 16. Before and after example of bank terracing and trail improvements in Salida, CO

The last proposed access point is downstream of Structure #5 on the west bank. This access point includes trails and terracing leading to the river. This point should be ADA accessible and REP anticipates it will be a focal point of the park. This access point would serve as a final take-out for in-stream park users and a place for beginners to practice their skills in tranquil, yet moving, water. All of these improvements are envisioned to be attractive, functional, permanent, and designed to blend with and improve the natural environment. Figure 16 shows an example of bank terracing and trail work completed by REP.

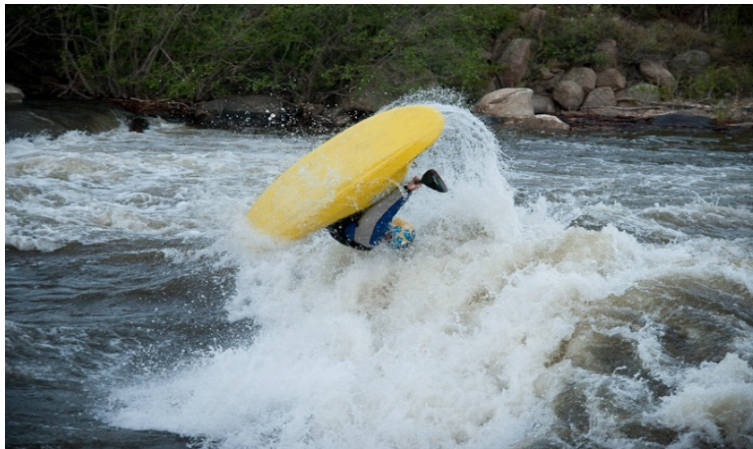
Figure 17: A state-of-the-art REP feature built in 2010

The six drop structures will be designed using REP’s experience with in-stream structures and the subtle geometric characteristics that have proven to create valuable features (See Figure 17). The structures are generally called “U” structures, which are typical REP whitewater structures that create waves or holes that cater to recreational and freestyle kayakers and fishermen. These structures are constructed using large, grouted rock anchored into the bed and bank of the river. The structures have a gradual slope to allow for fish passage. In addition, the deep pools downstream of “U” structures provide excellent habitat for fish, especially during spring and summer runs. Figure 18 shows examples of two typical “U” structures. Each feature will be constructed slightly different to create diverse wave, wave-hole, hole, and jet features. It is anticipated the structures will create valuable features for slalom and downriver training and racing, including eddies, complex pool currents, waves, jets, and pillows.

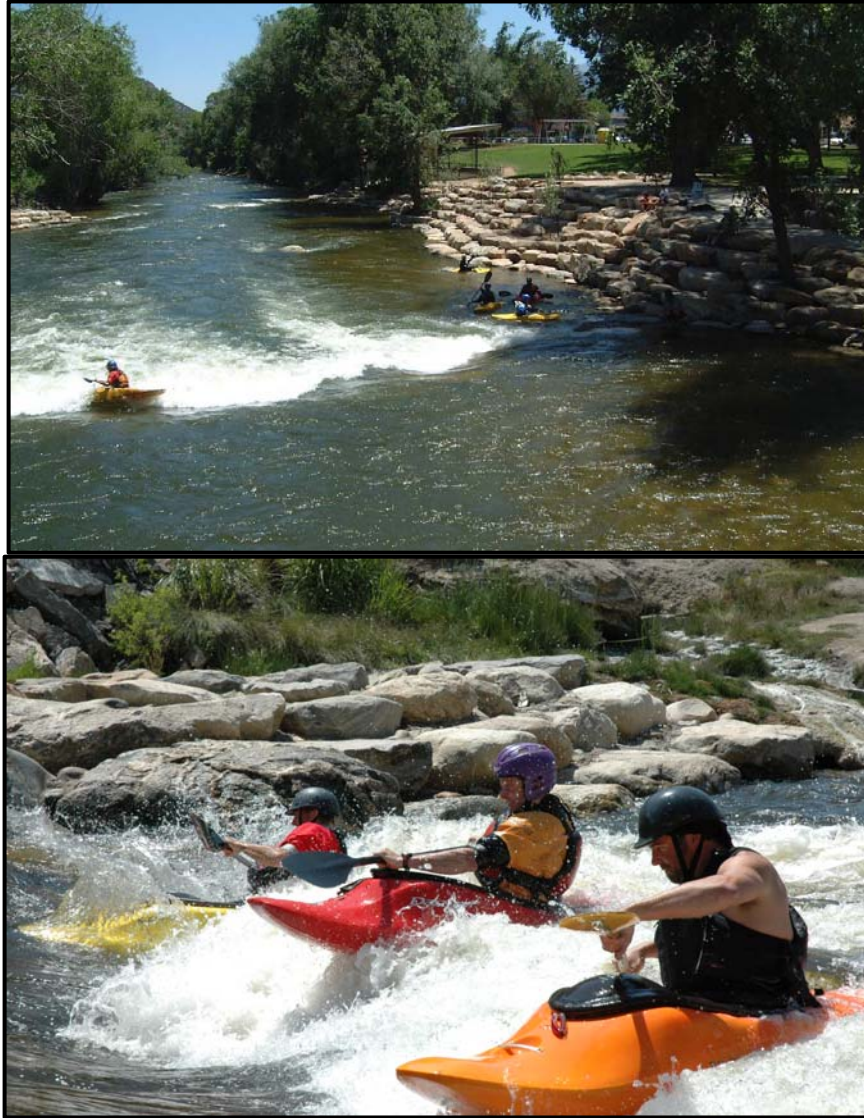
Figure 18. (top to bottom) A "U" structure designed for instruction in Salida, CO and freestyle kayakers utilizing another "U" structure in Steamboat Springs
